TELEDYNE CONTINENTAL[®] AIRCRAFT ENGINE
CRITICAL SERVICE BULLETIN
Compliance Necessary To Maintain Safety

CATEGORY 2
CSB96-8
FAA APPROVED
SUPERSEDES M92-16.

SUBJECT: REPLACEMENT OF AIRMELT (NON-VAR) CRANKSHAFTS

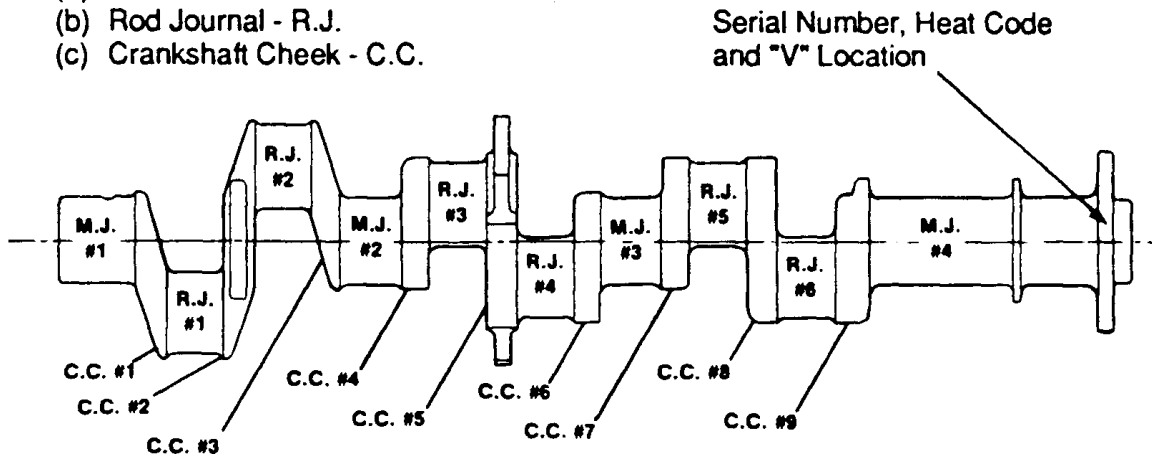
FIGURE 3

- (a) Main Journal - M.J.
- (b) Rod Journal - R.J.
- (c) Crankshaft Cheek - C.C.
